**AES PUERTO RICO, L.P.
Guayama, Puerto Rico**

June 19, 2014 NPDES Enforcement Case Support Inspection Briefing

**José A. Rivera, BSCE
Regional Storm Water Specialist
Caribbean Environmental Protection Division**

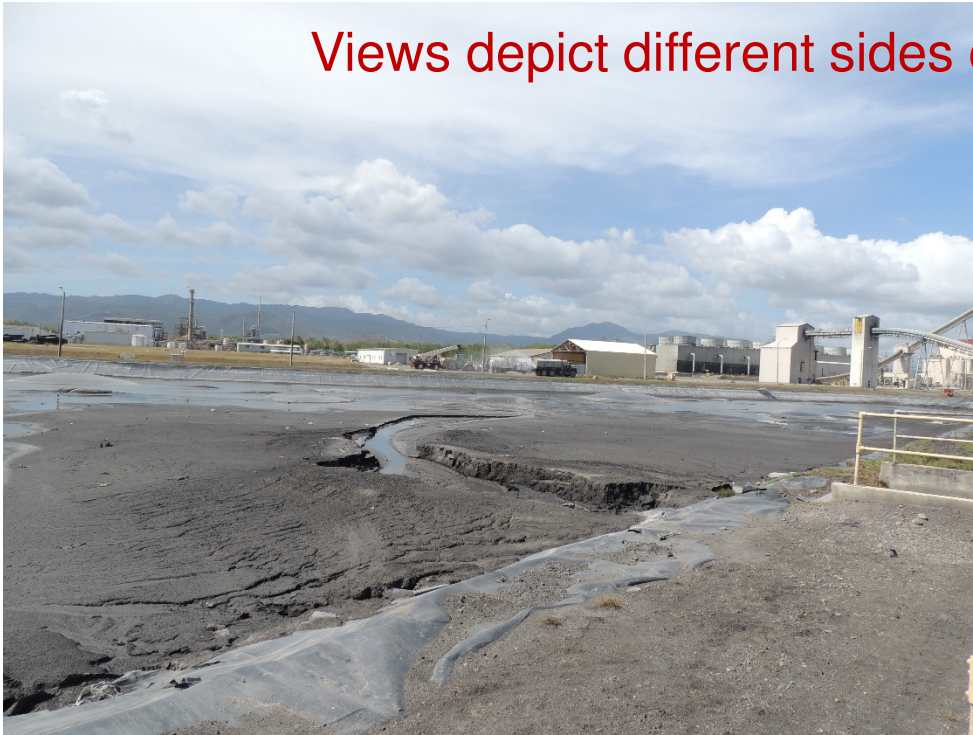
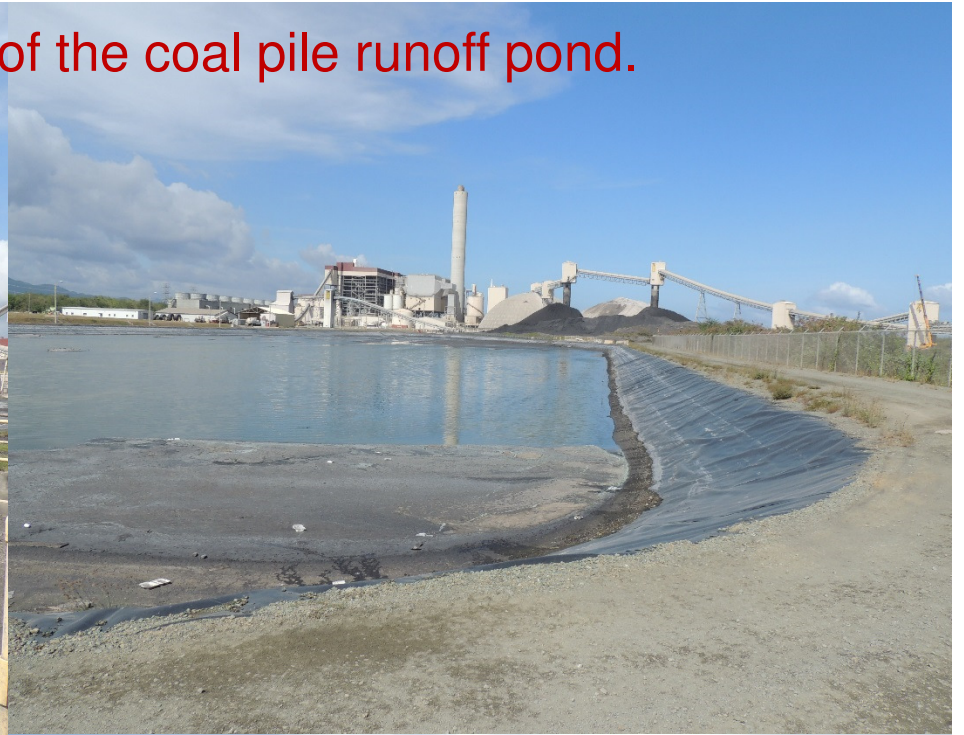
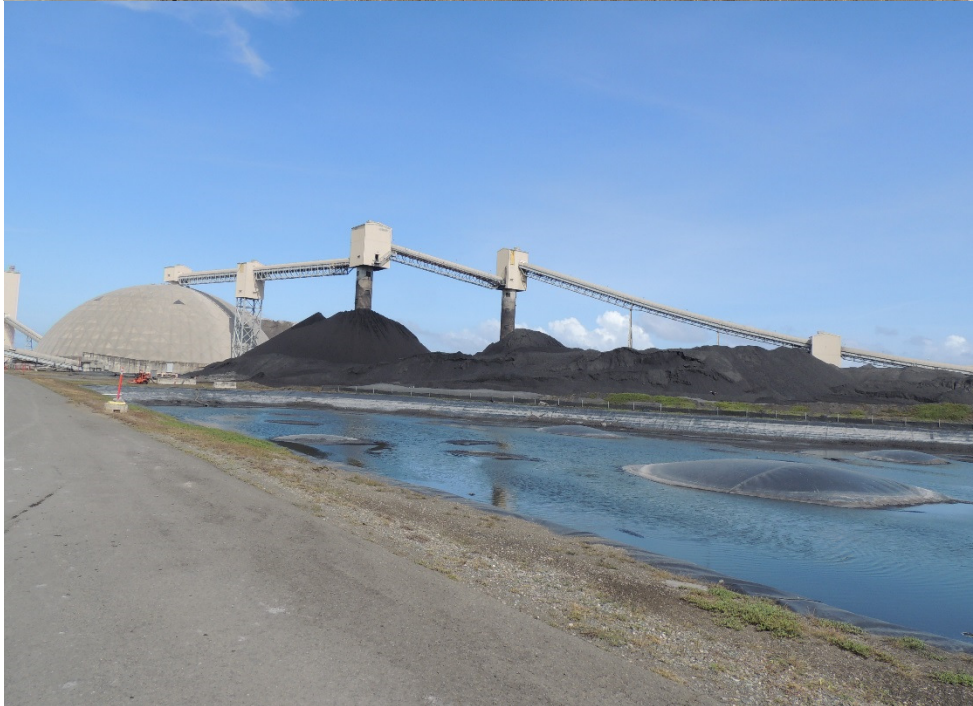
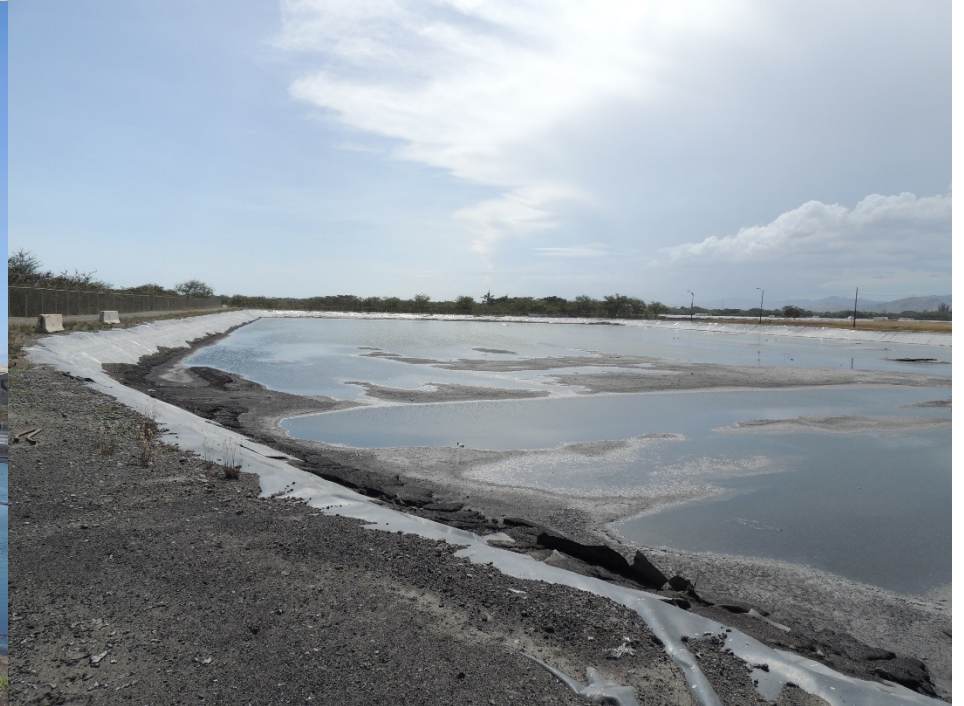
Views depict different sides of the coal pile runoff pond.

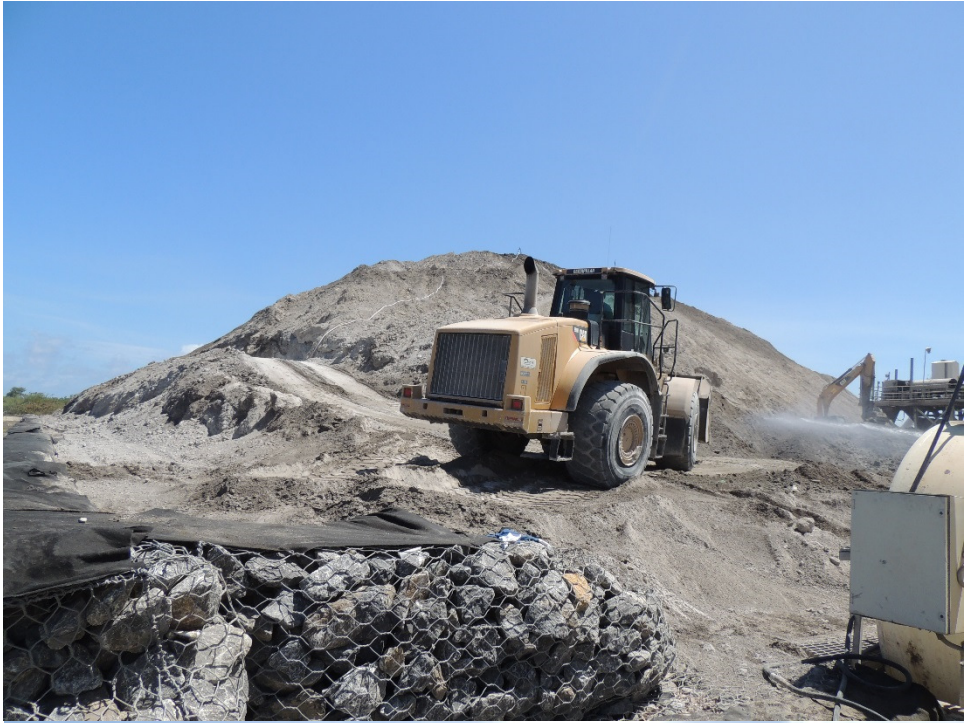
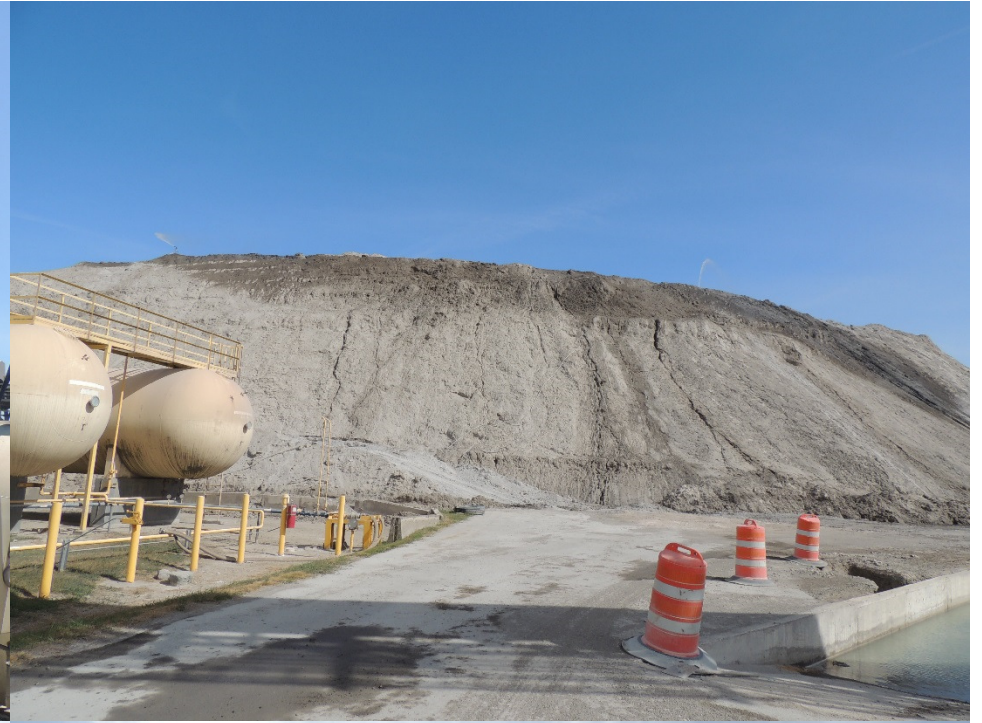
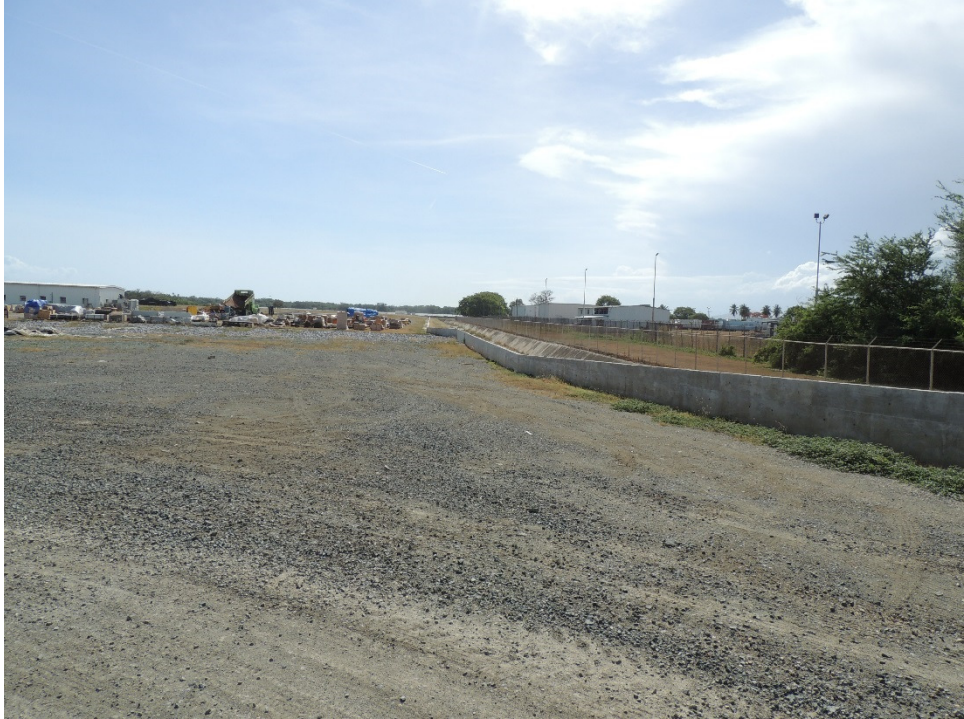
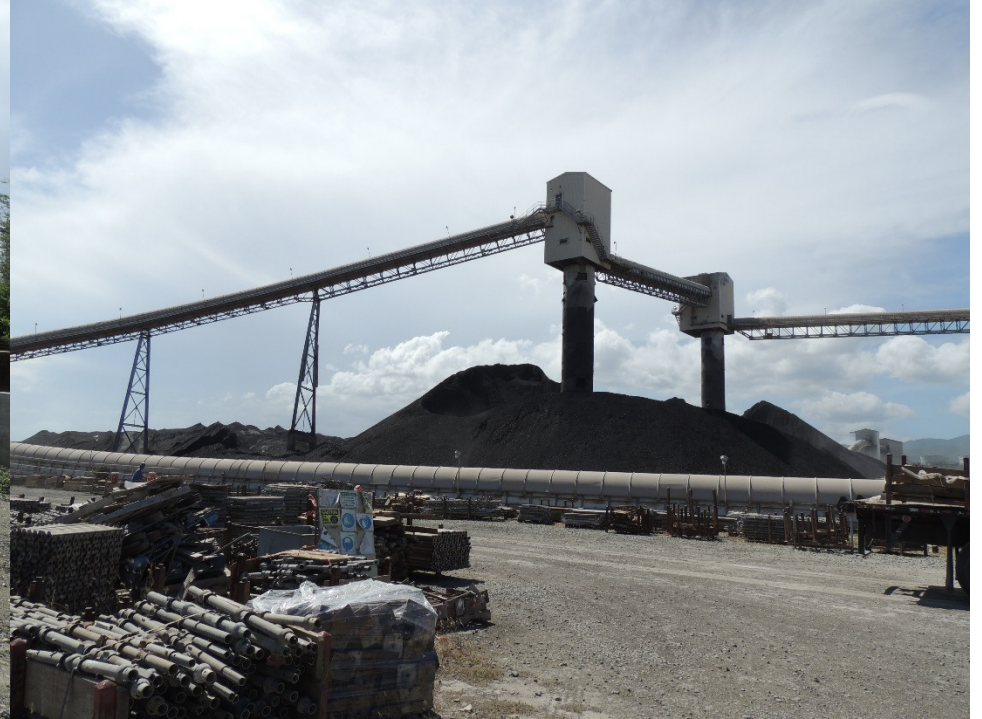
- The Aggremax storage pile continues to grow to a height greater than 70 feet. About 30,000 cubic yards are produced every month. Barge capacity is 20,000 cubic yards. Only being able to load one barge per month due to lack of barge availability.

- Uncontrolled Dust and Lack of Soil Stabilization
 - Water irrigation in facility roads applied (by water tank-mounted truck). One truck not enough to maintain wet roads and other areas at site.

- Water irrigation in Aggremax pile -- inefficient use of sprinklers (about 4 observed) at top of the pile.
 - One employee watering (hose) areas in which heavy equipment observed within the Aggremax areas.

- Particulate matter (dust, fine silt, etc.) observed all over the place.
 - No soil stabilization BMPs at Aggremax and coal pile slopes.
 - Numerous areas observed in need of crushed stone re-application for soil stabilization and dust control (e.g., dirt road on south side of site).

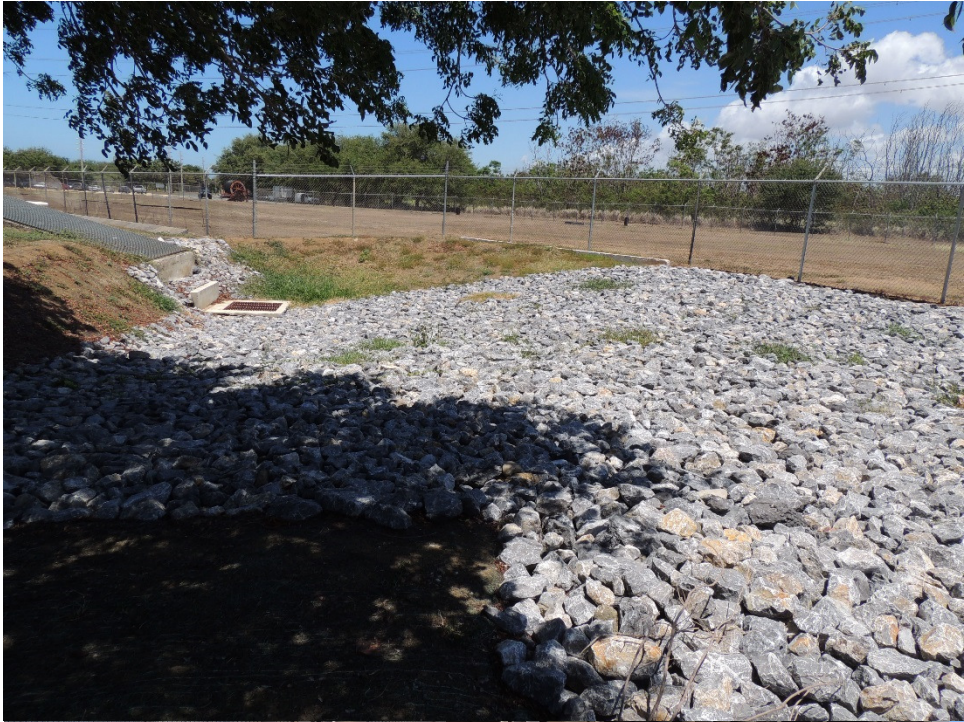
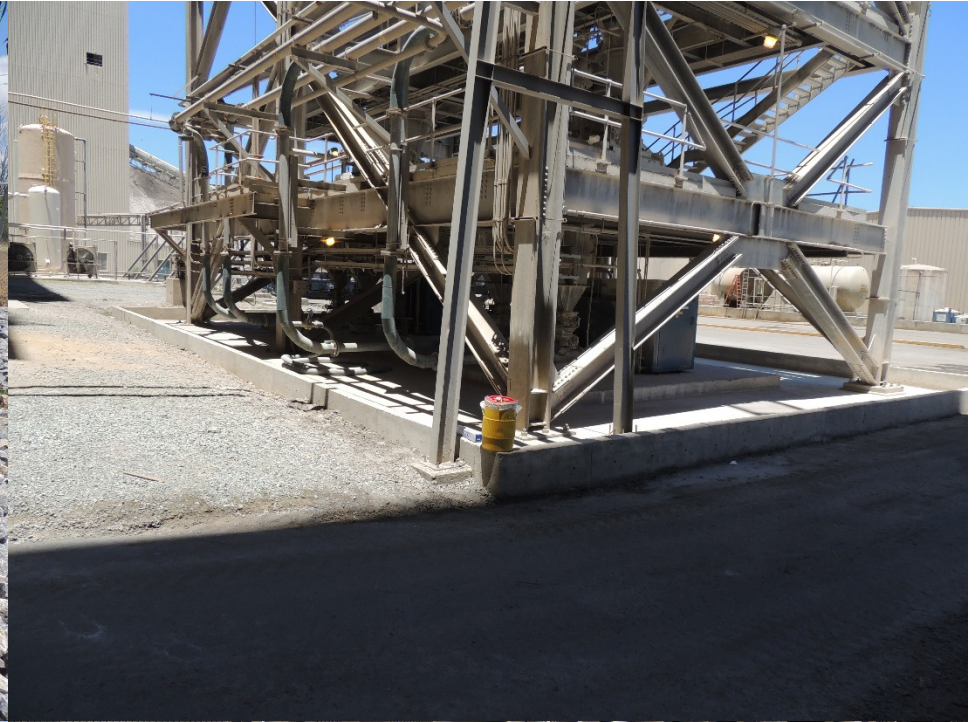
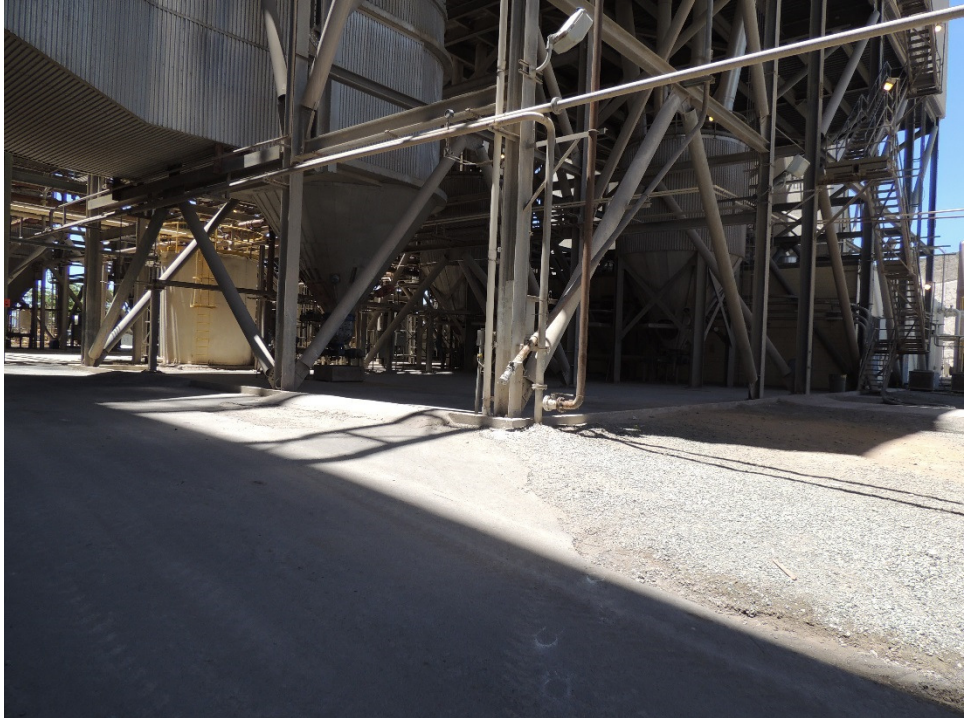
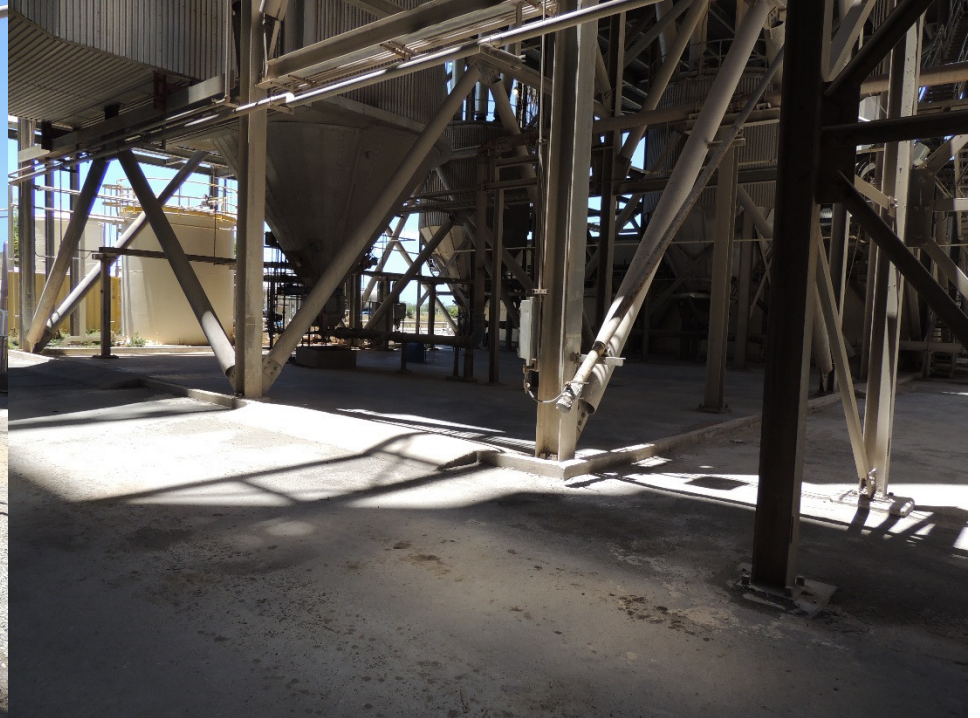
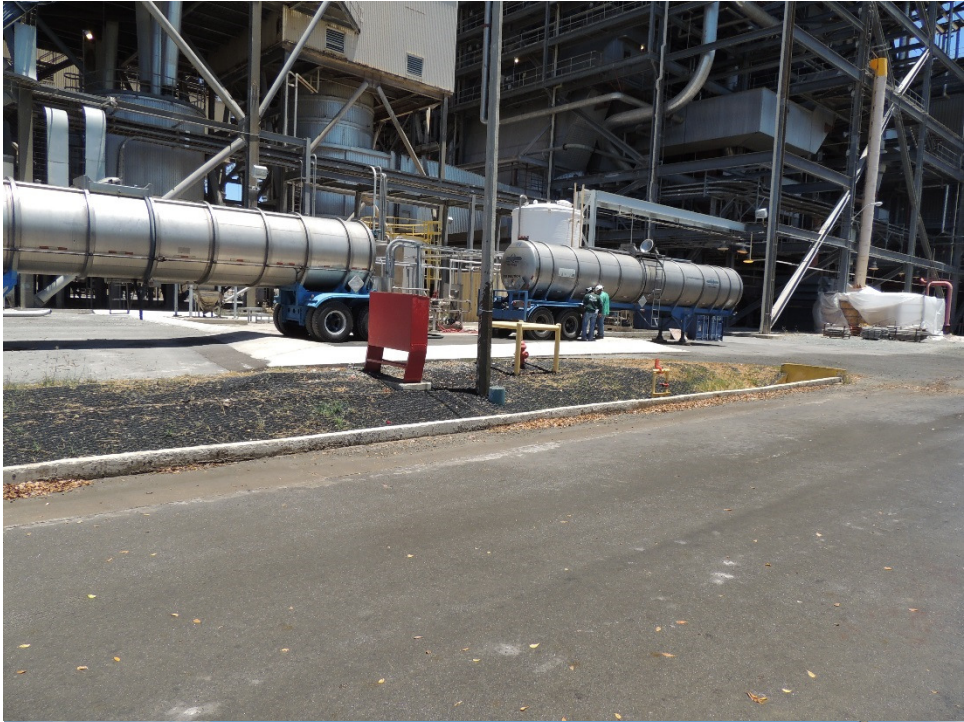
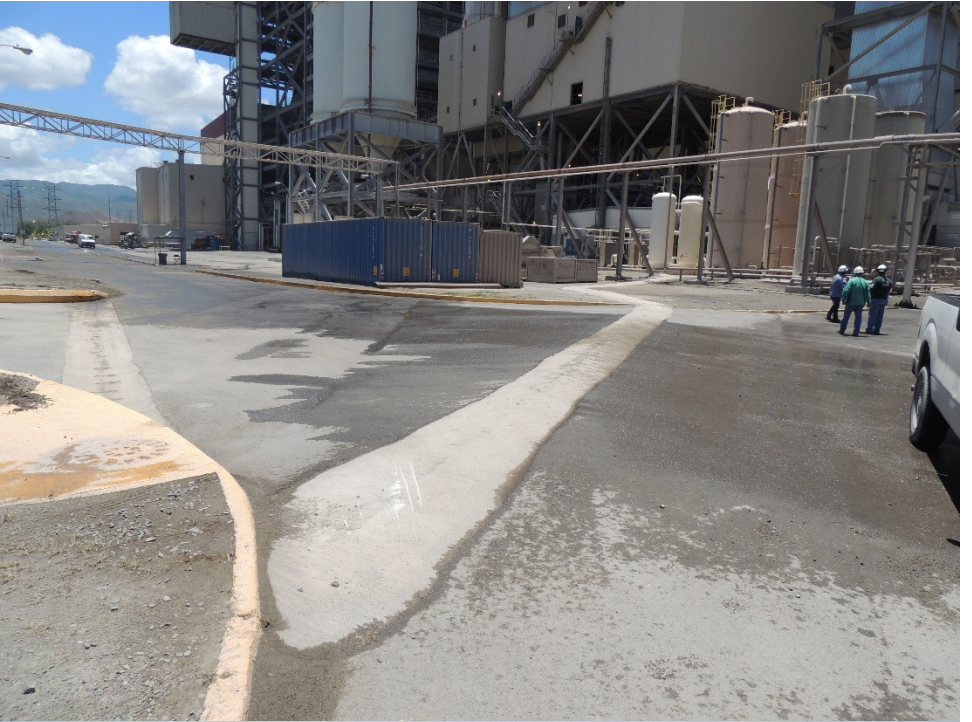
- Adequate Structural BMPs constructed/installed to segregate ash/coal/limestone from other industrial areas:
 - Re-pavement and re-grading
 - Low wall construction at several areas
 - Secondary containment
 - Gabions installation for erosion control
 - Relocation of Outfall 002
 - Segregation of stormwater from process wastewater

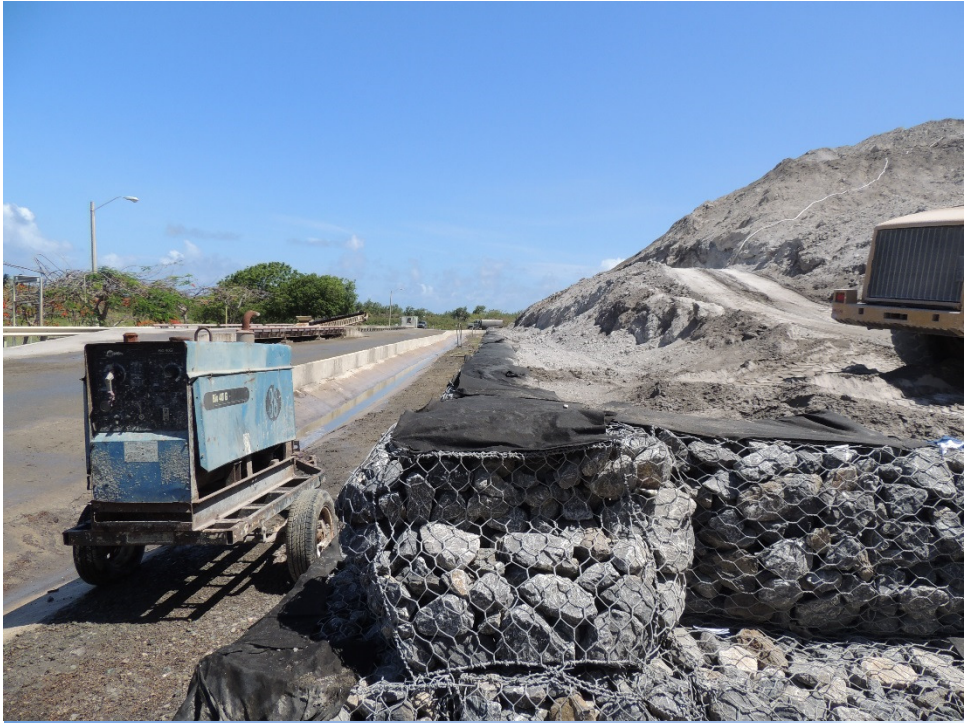
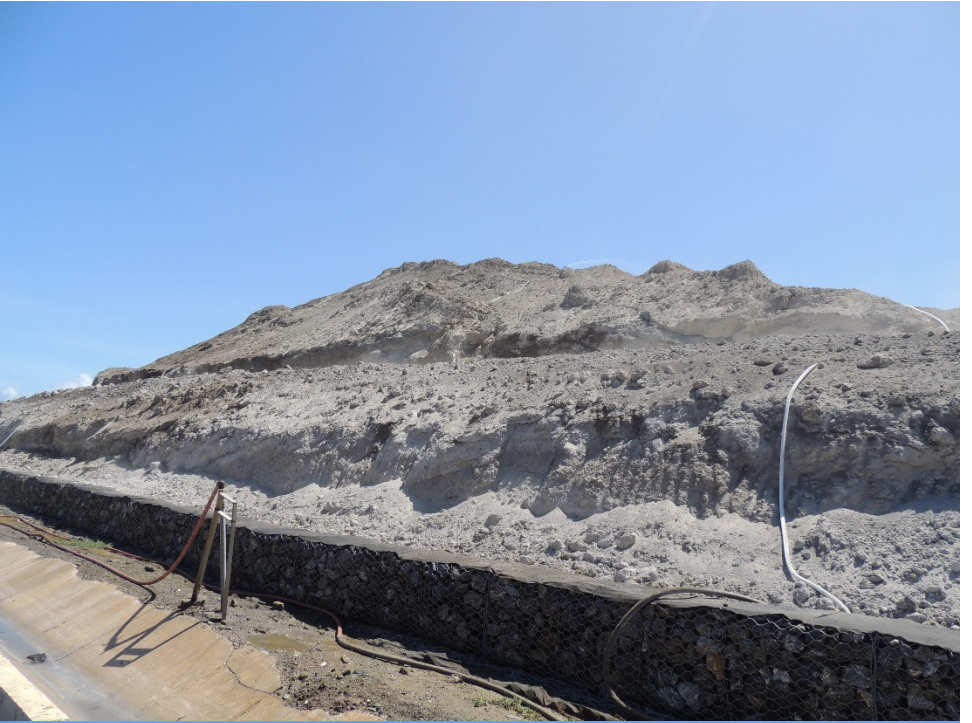
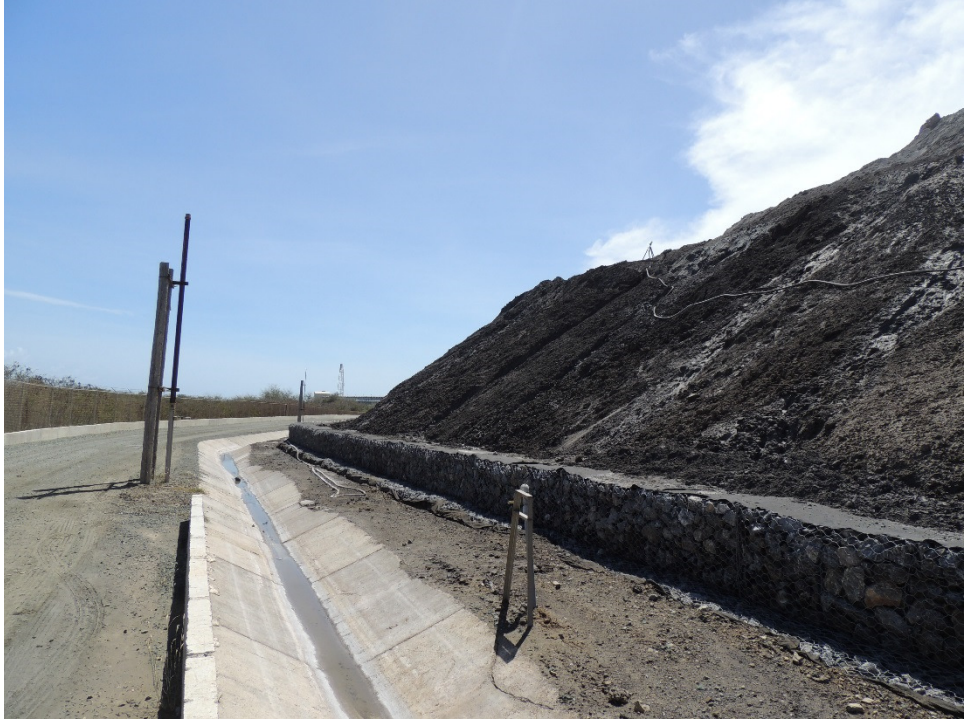
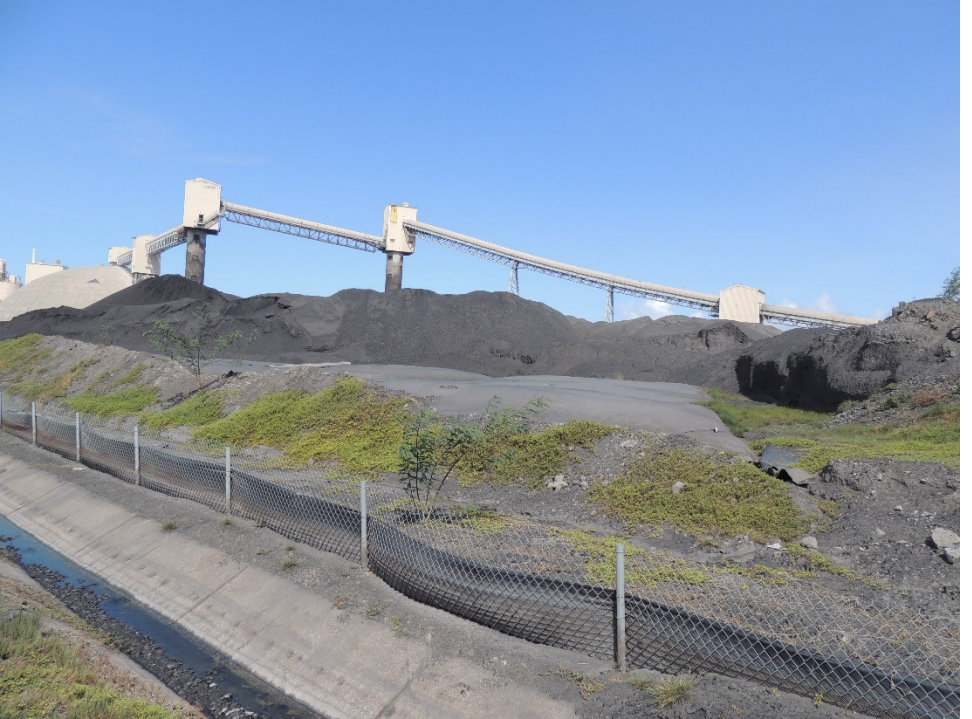
- Over-use of BMP controls and lack of replacement and maintenance at ash/coal/limestone areas:
 - Aggremax pile grew to a point in which gabions are almost covered and inefficient.
 - Silt fence in coal storage areas (north and south) need to be replaced.
 - Coal pile runoff pond yet to be cleaned and placed into operation. AES is a year late on this task but notified that it will be done by end of July, 2014. I doubt it based on previous experience with SW Pond.
 - Inadequate maintenance of concrete swale which collects and convey runoff into the coal pile runoff pond.

- Meeting with AES' environmental coordinator to complete discussion about pending actions in ACO, such as:
 - Coal Pile Runoff Pond
 - Revision to SWPPP
 - Reconfiguration of Sampling Points 002 and 003
 - Protection of inlets/catch basins
 - Slope stabilization for Aggemax and coal piles
 - Other BMPs that require maintenance and implementation

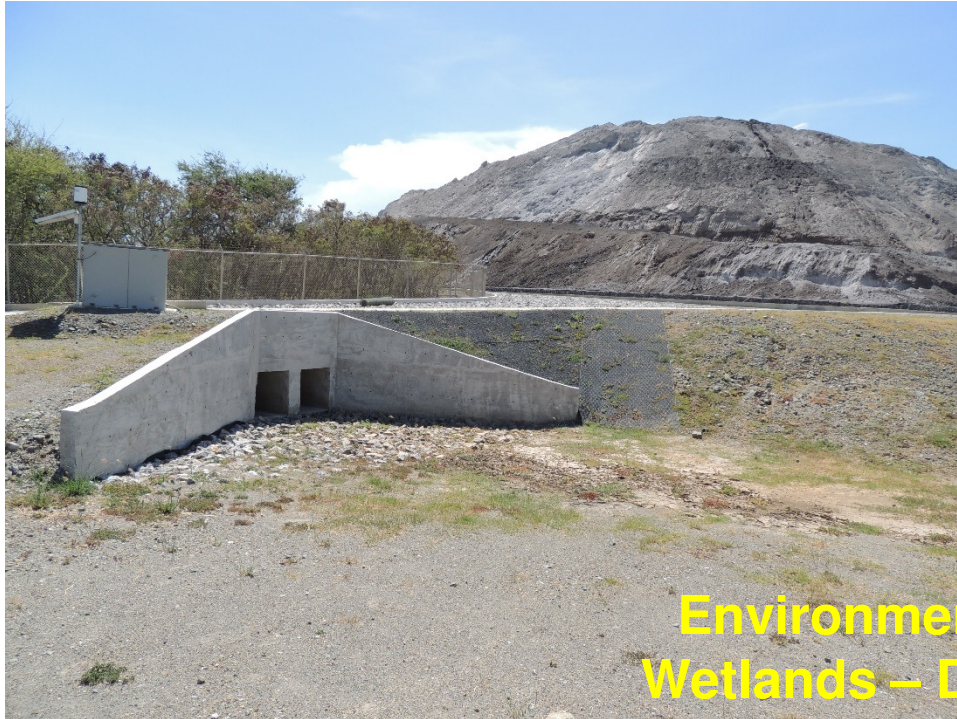
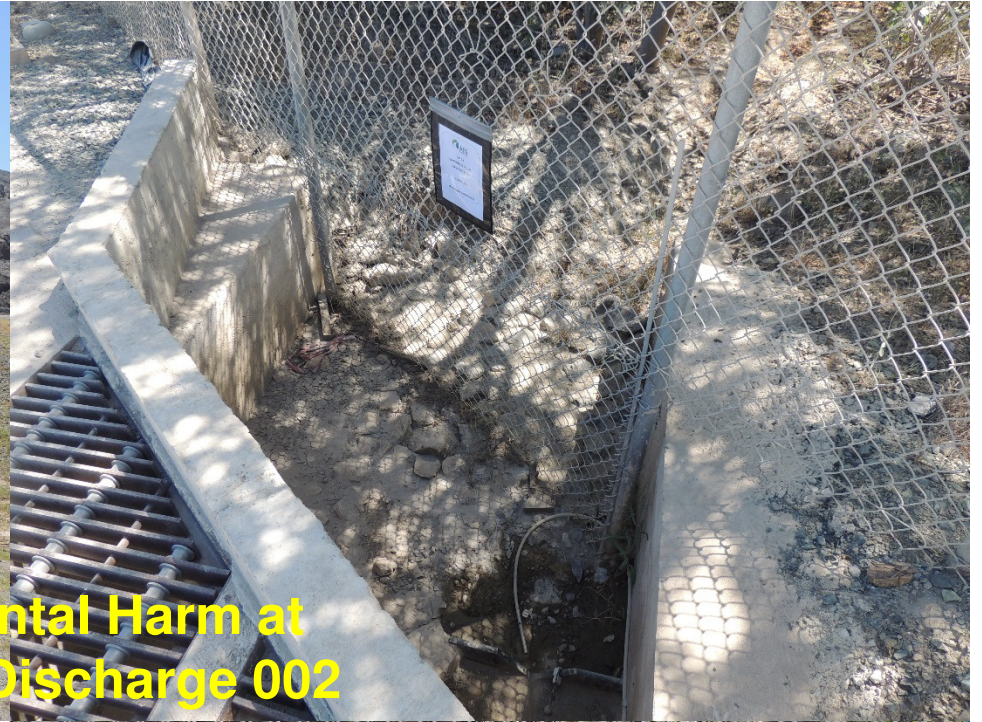
- Inspector observed (as never before) sediments, particulate matter and dust all over the place and employees without wearing respiratory protection.
- Particulate matter exacerbated due to dry weather, high winds and lack/inappropriate dust controls.
- Sediments accumulation at discharge point 002.
